Your Inspection Report

1234 Home Place
Your Town, TN

INSPECTION DATE:
Wednesday, March 27, 2013

Report No. 1001, v.6

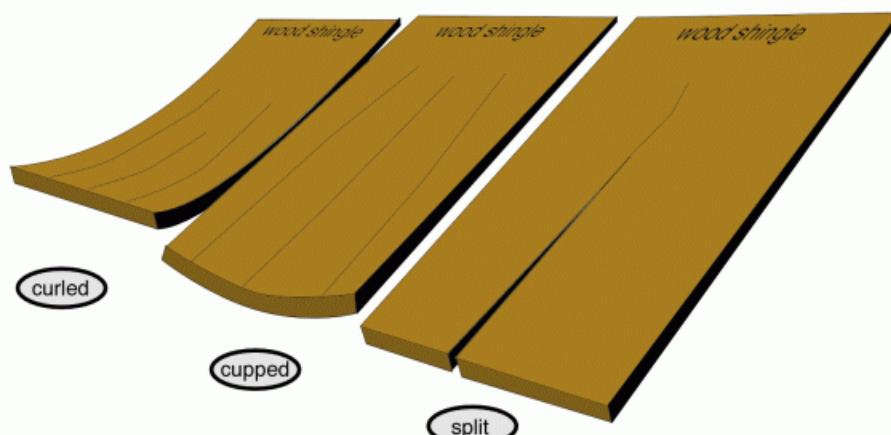
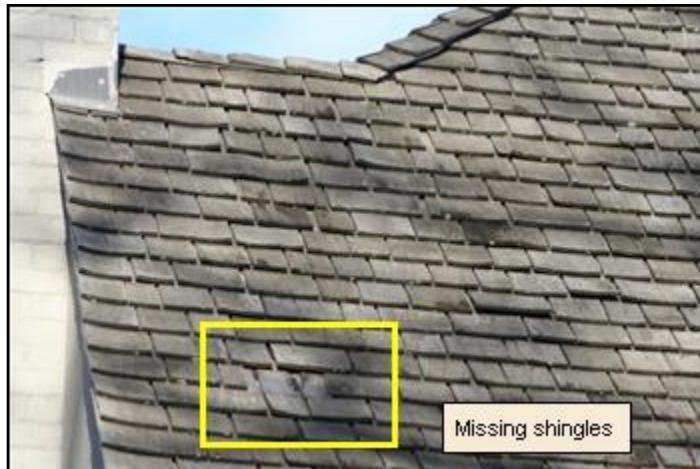
Condition: • [Old, worn out](#)

Curling, cupping and splitting wood shingles

Task: Replace

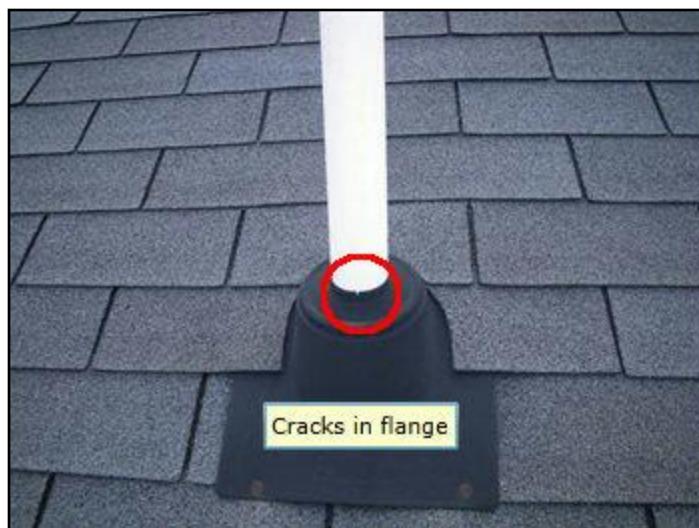
The drain waste vent flanges are beginning to crack at the pipe connection. These are probably leaking a small amount

of moisture now, it just isn't enough to show through into the house. Replace these flanges soon to avoid any damage to interior finishes or contents.

Damage

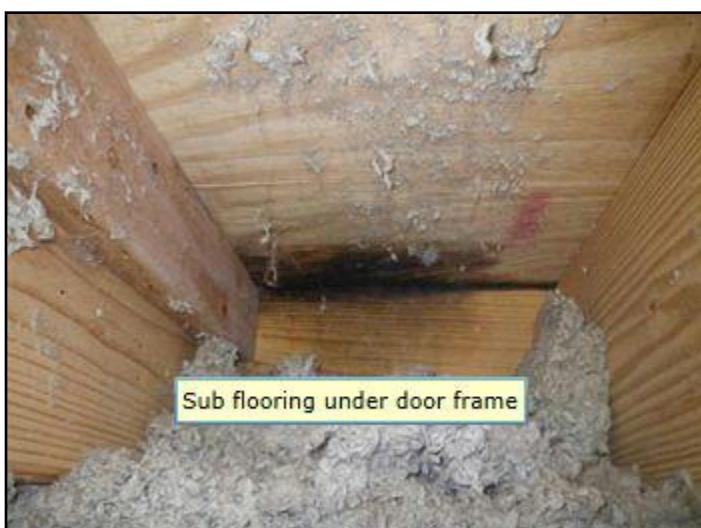
Both sides of the back door frame have rotted and is allowing moisture to enter into the flooring and joists in the crawl space. I recommend repairing this door frame or replacing it as necessary.

Rot in flooring

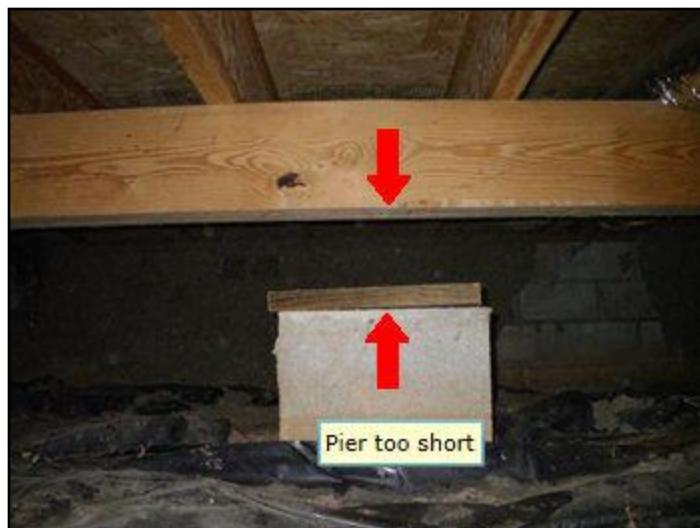
I found one pier that would be at the front of the house in the living room area. This pier is too short to supply any support for this girder. I recommend increasing the height of this pier to help support the load of the living room area.

Missing

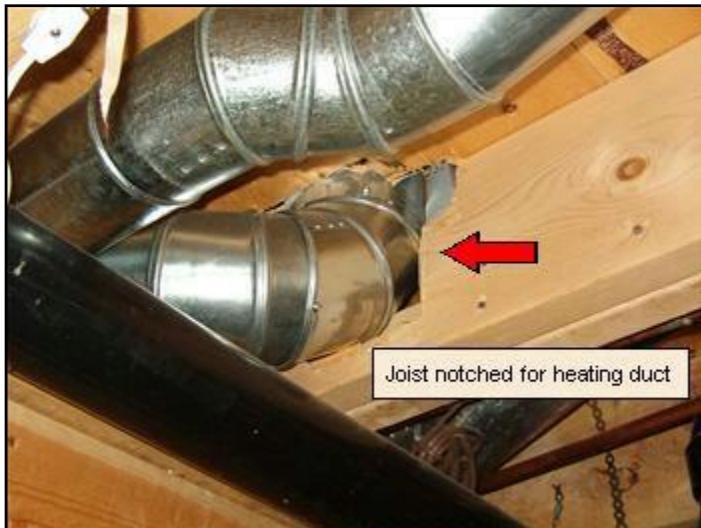
Floor joists must be reinforced when they are notched out for plumbing or heating features. I recommend a licensed contractor repair this floor joist immediately.

Notches or holes

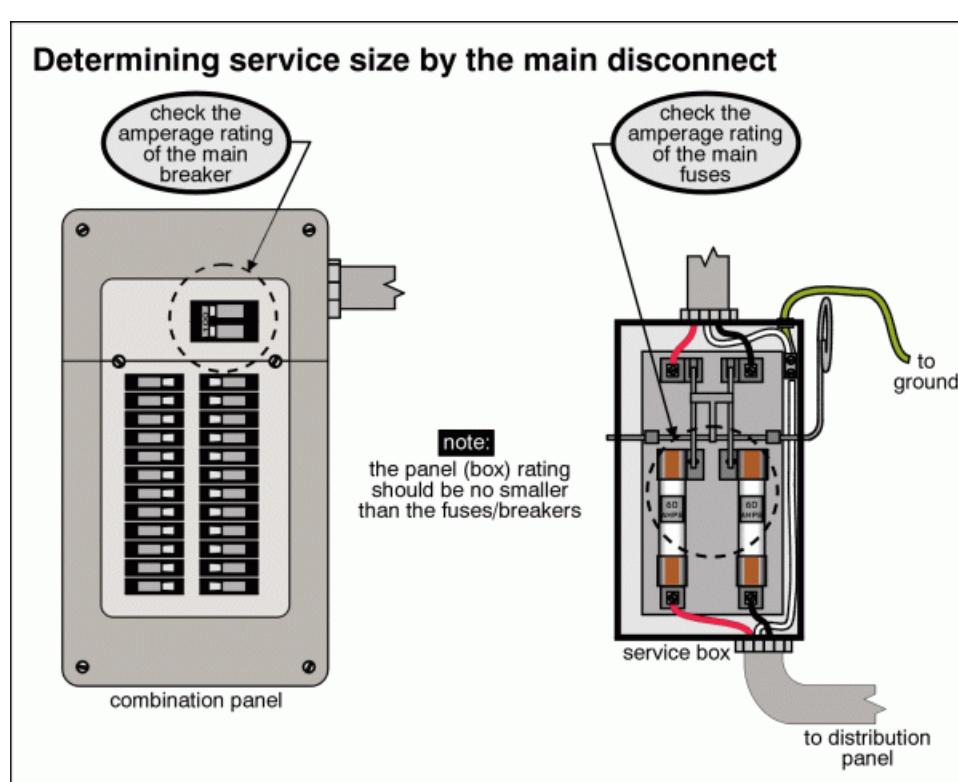
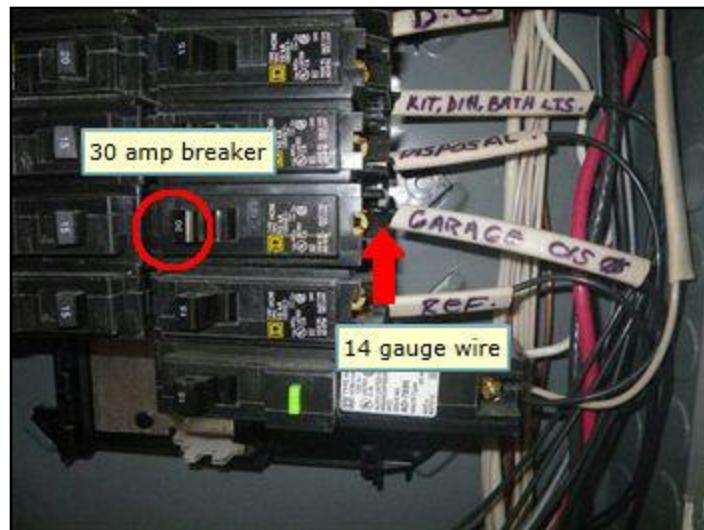
This 30 amp breaker is labeled to supply the garage door opener. It has a 14 gauge wire attached to it. In electrical circuits for residential use a 14 gauge wire should be protected by a 15 amp circuit breaker. I recommend an electrician evaluate this circuit and either approve of it in writing or make the necessary repairs.

Wrong fuse or breaker size

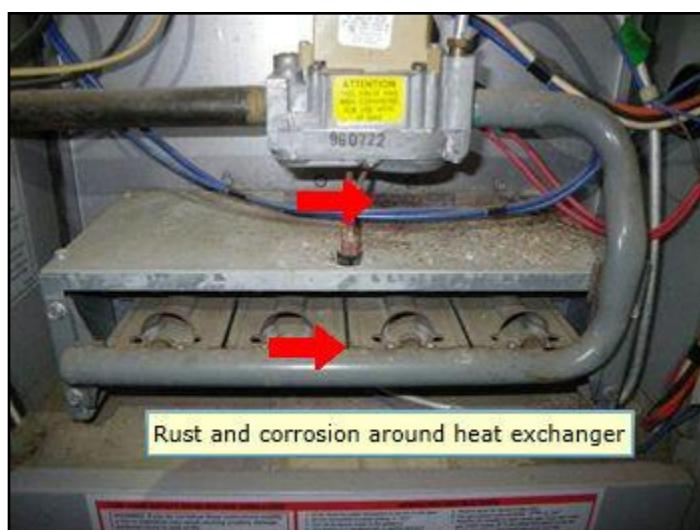
There is rust and corrosion falling into and all around the heat exchanger in this furnace. I recommend a HVAC technician clean and evaluate the condition of this furnace. I further recommend a carbon monoxide test be run to insure the safety of operation of this unit. This unit is 17 years old and may be near the end of its useful life.

Rust, dirty, obstructed

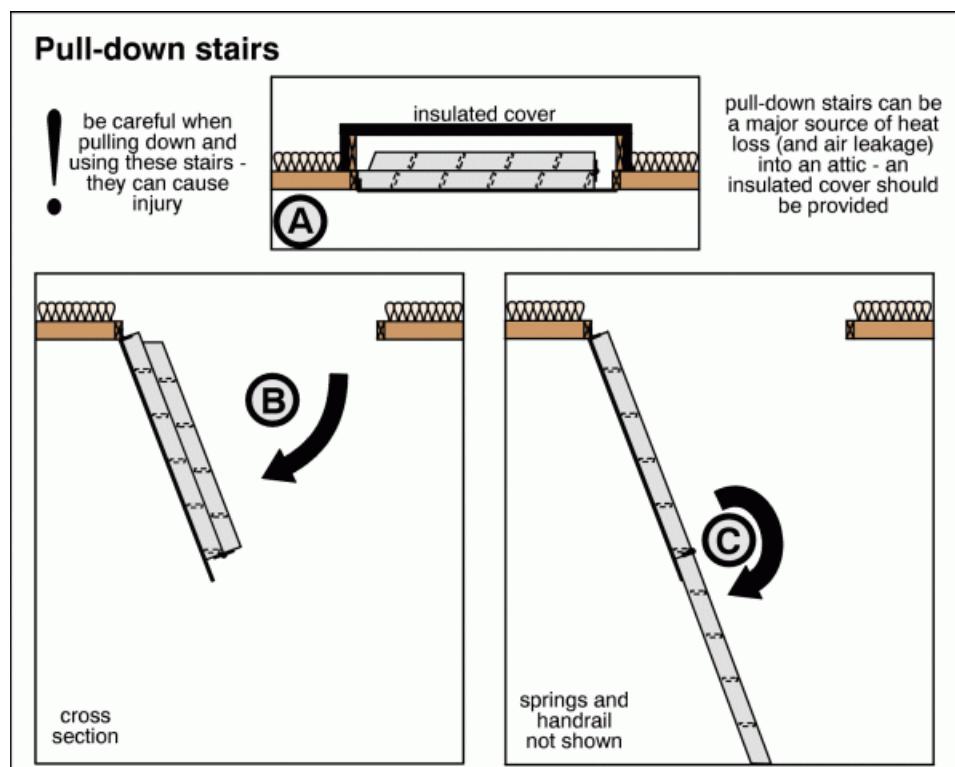
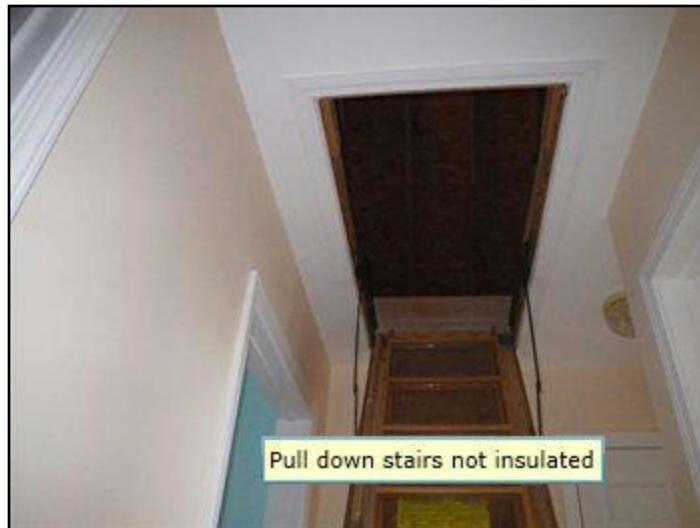
I recommend installing insulation over these pull down stairs for the second floor attic area. There are insulating blankets or domes that can be used to help prevent heat loss through this opening. Another good thing to do is to install weather stripping around the edges of the opening that will seal when the stairs are pushed up.

Not insulated

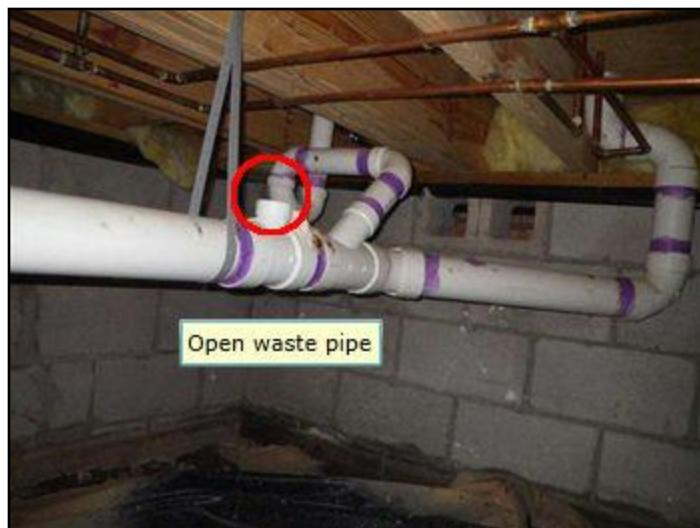
The jacuzzi tub drain was never connected to this drain waste pipe. The connection was left open during construction. You can see where toilet solid waste has overflowed from the pipe opening and is spilling into the crawl space. I recommend a plumber either close this opening or connect the jacuzzi tub in an appropriate manner.

Missing

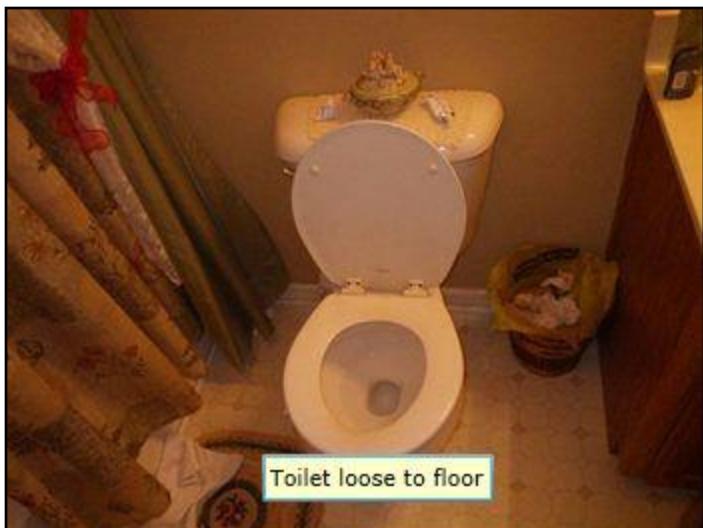
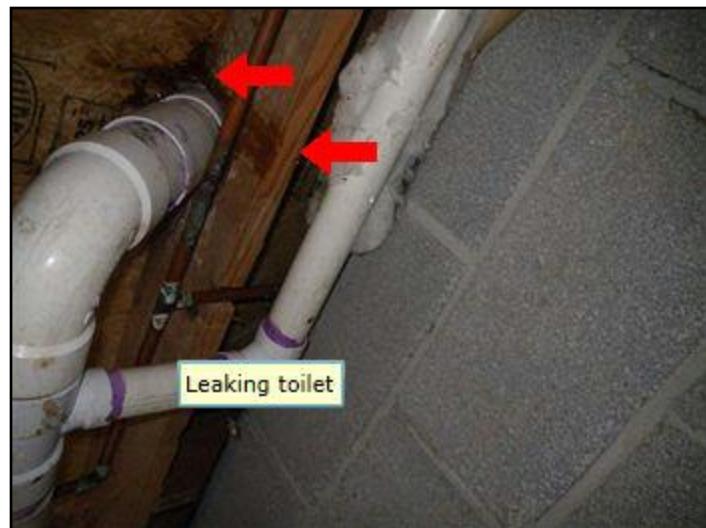
This toilet was loose to the floor on the day of inspection. When viewed from underneath you can see that it is leaking. I recommend a plumber evaluate the cause of this failure and make necessary repairs.

The wax ring may be leaking or the toilet...

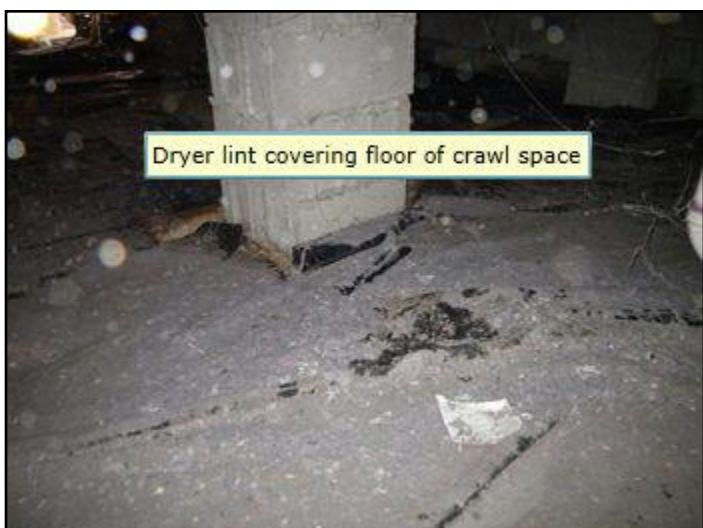
The dryer vent is currently going directly into the crawl space. This allows all of the dryer lint to build up in the crawl space and became a hazard for fire and mold. I recommend installing a proper dryer vent line that goes to the exterior of the building.

Dryer lint in crawl space

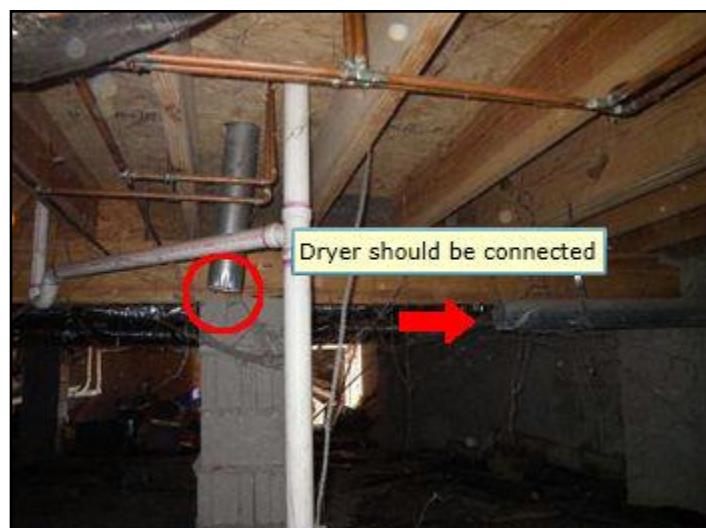
Dryer not connected
